Subject: Department of Natural Resources Washington Geological Survey,
School Seismic Safety Assessment Project, Contract No. AE 410 -
Seismic Evaluation for **Centerville School District**

1. Centerville Elementary School, Main Building

1.1 Building Description

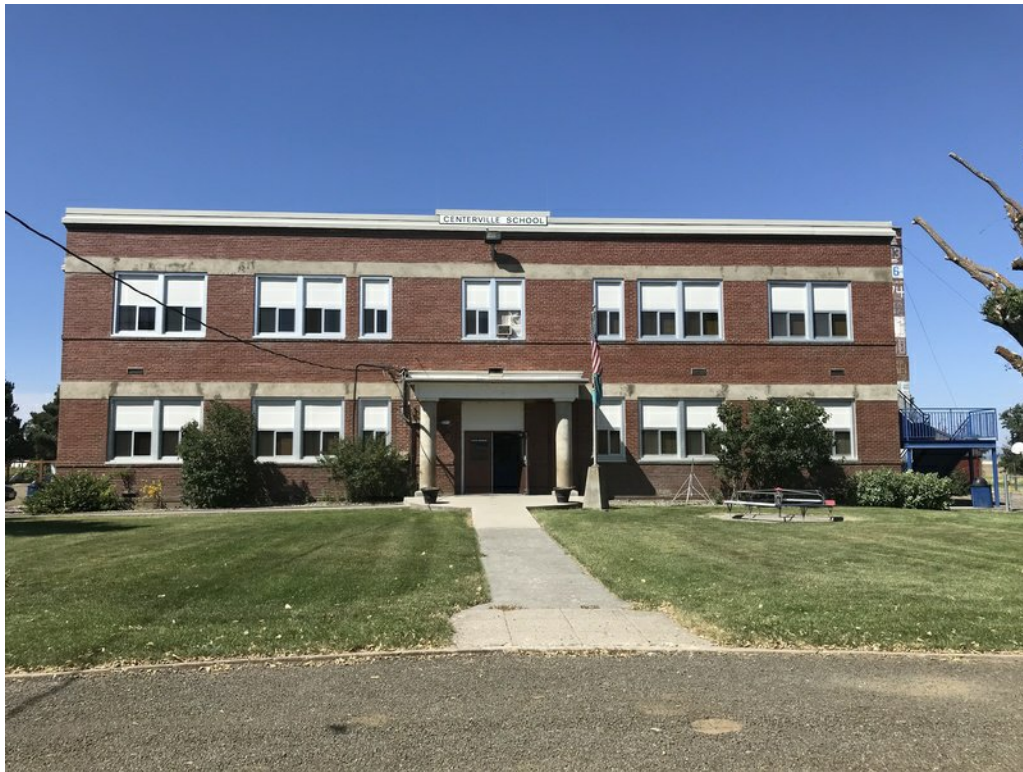
Figure 1-1. Centerville School - South Exterior

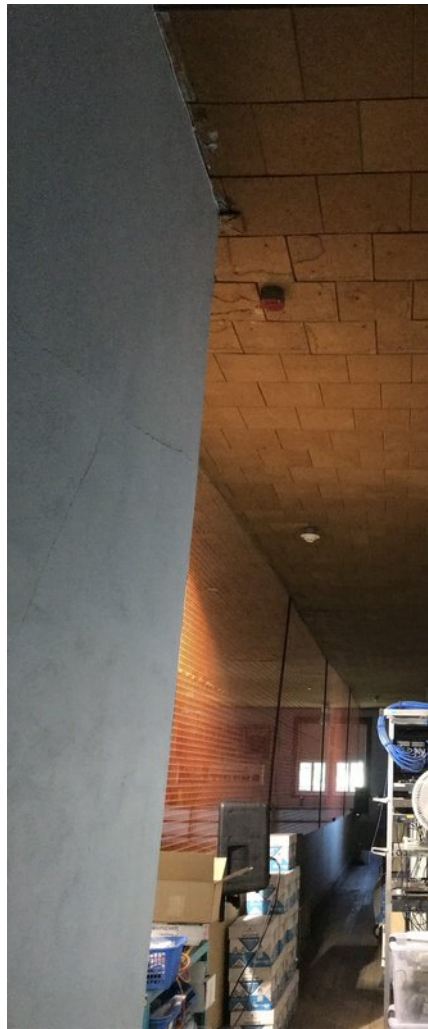
Structural System	Description
Structural Roof	Ceiling finishes show evidence of water damage.
Structural Floor(s)	No visible signs of corrosion, damage, or deterioration.
Foundations	Unknown.
Gravity System	Corrosion and cracking visible on exterior walls. Cracking visible on interior wall finishes.
Lateral System	Corrosion and cracking visible on exterior URM walls.

Figure 1-2. Evidence of Water Damage to Ceiling Finishes

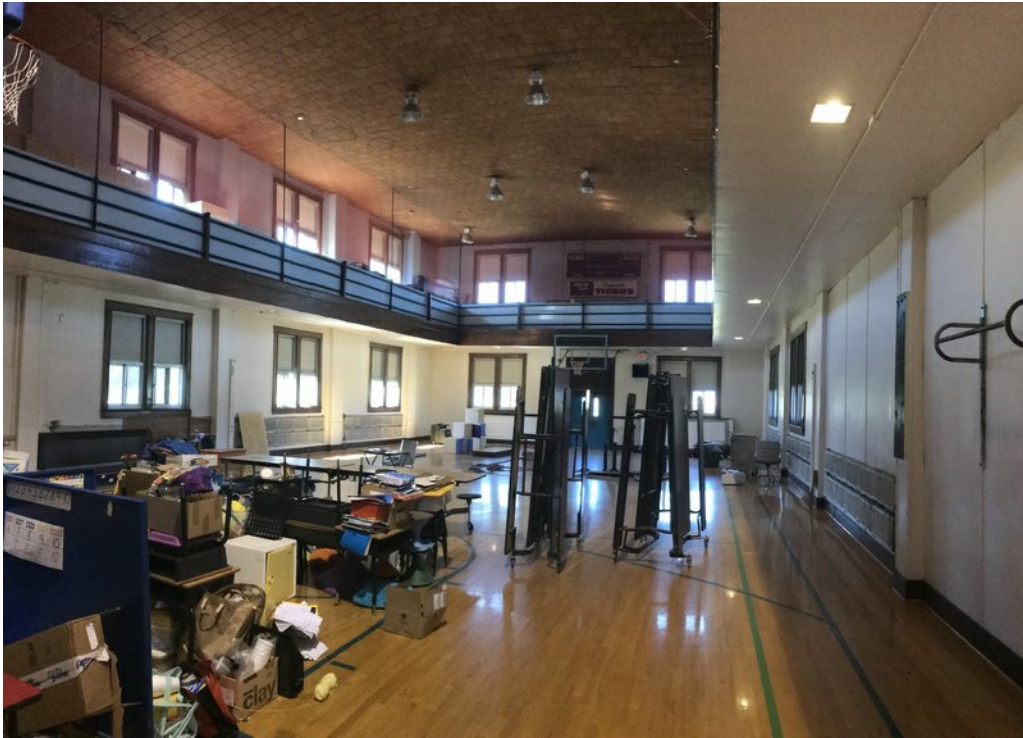
Figure 1-3. Multipurpose Room

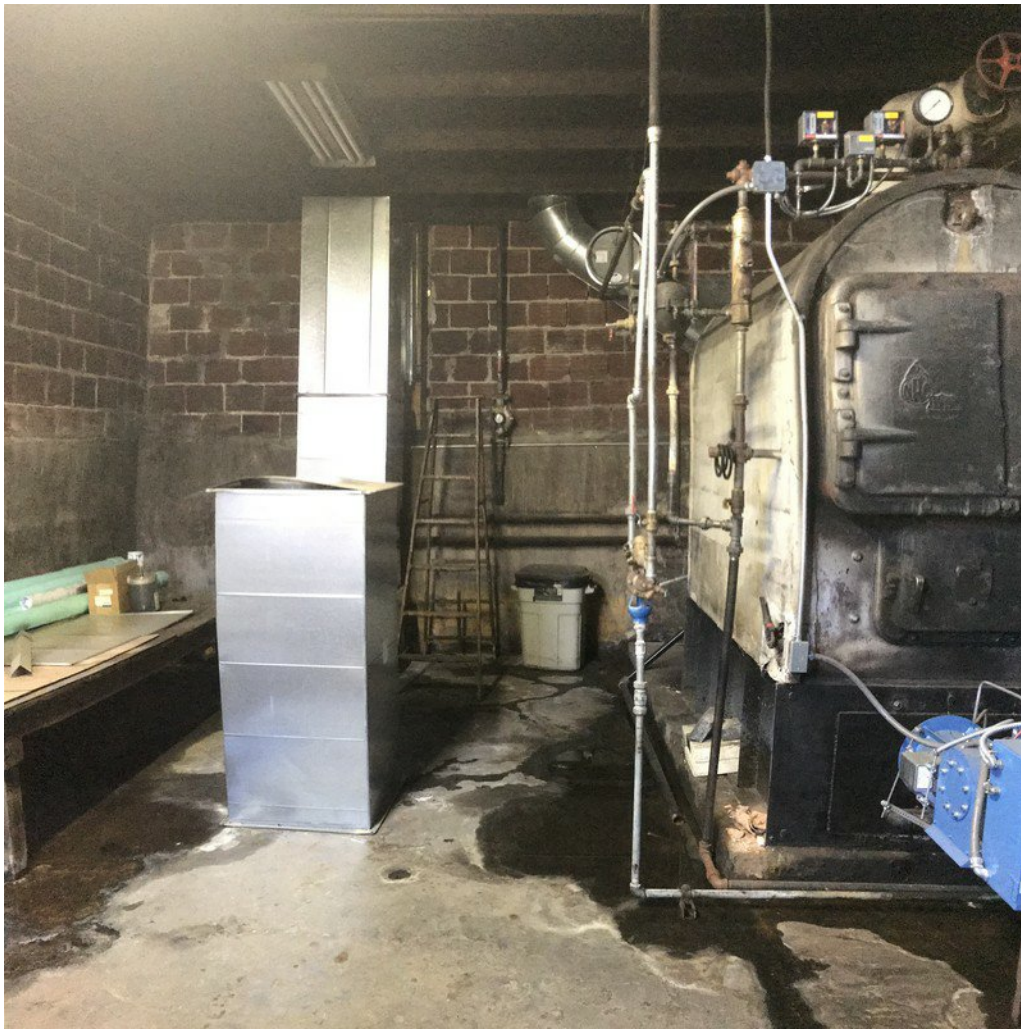
Figure 1-4. Boiler Room with Unbraced Equipment

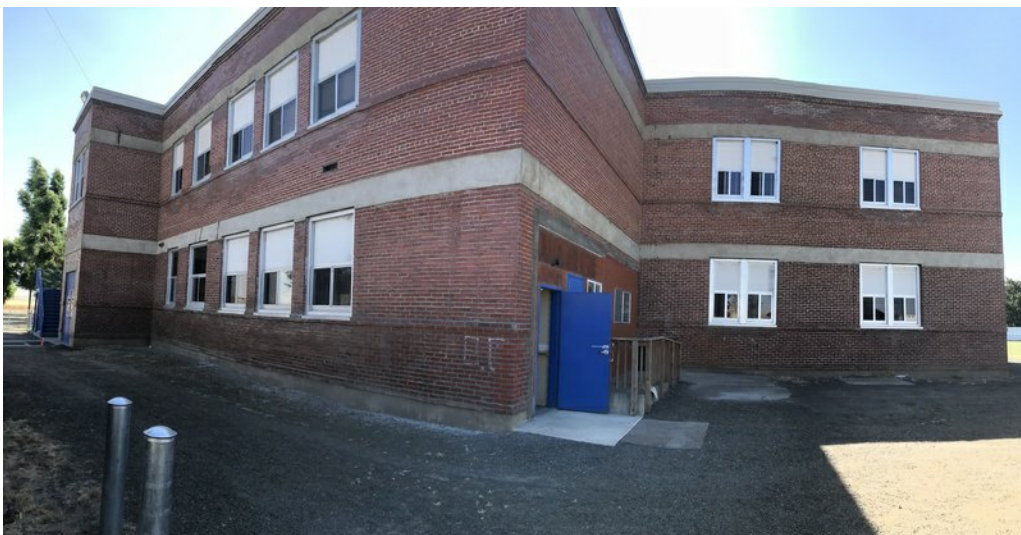
Figure 1-5. Centerville School - East Exterior

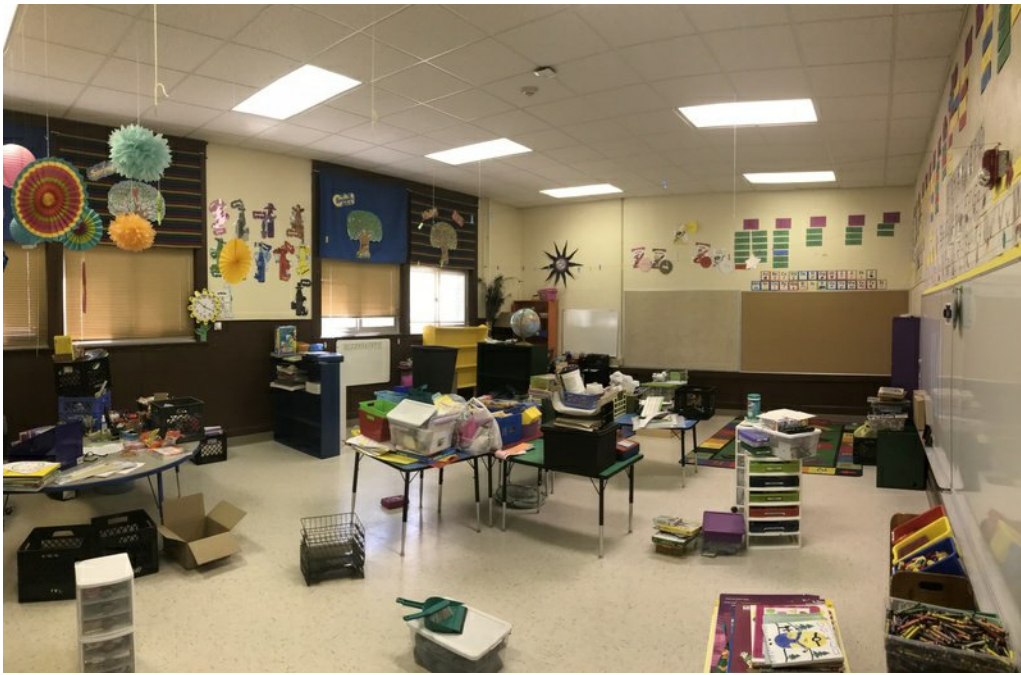
Figure 1-6. Typical Classroom with Unknown Light Fixture Bracing

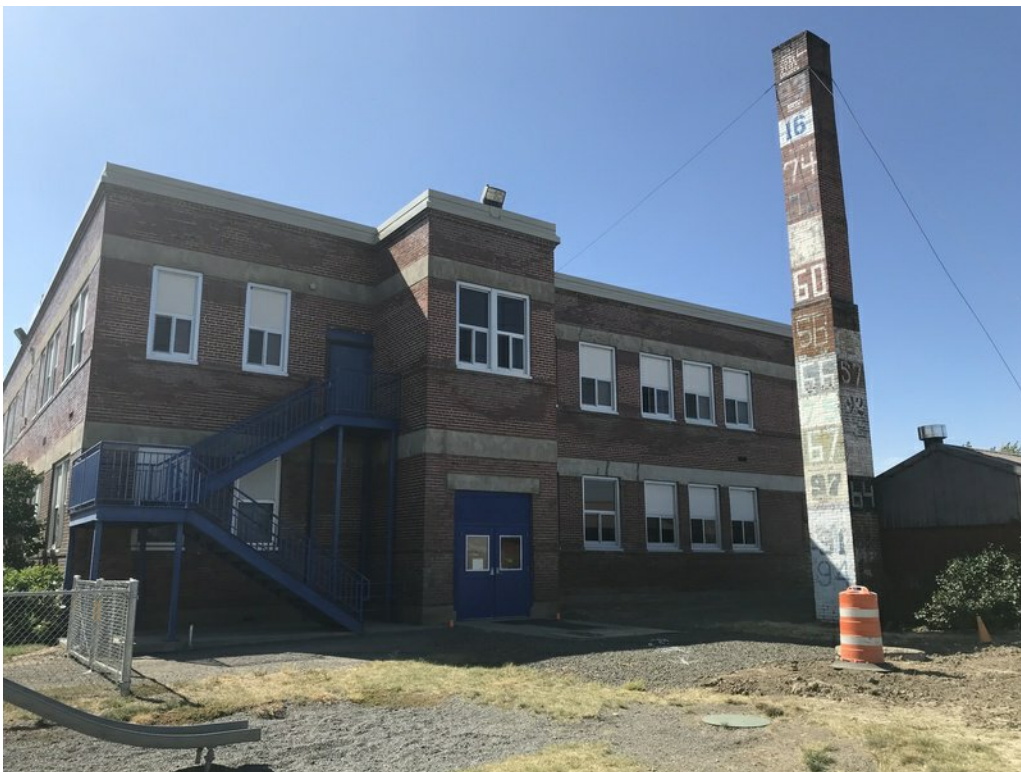
Figure 1-7. Centerville School - East Exterior with Unbraced Masonry Chimney

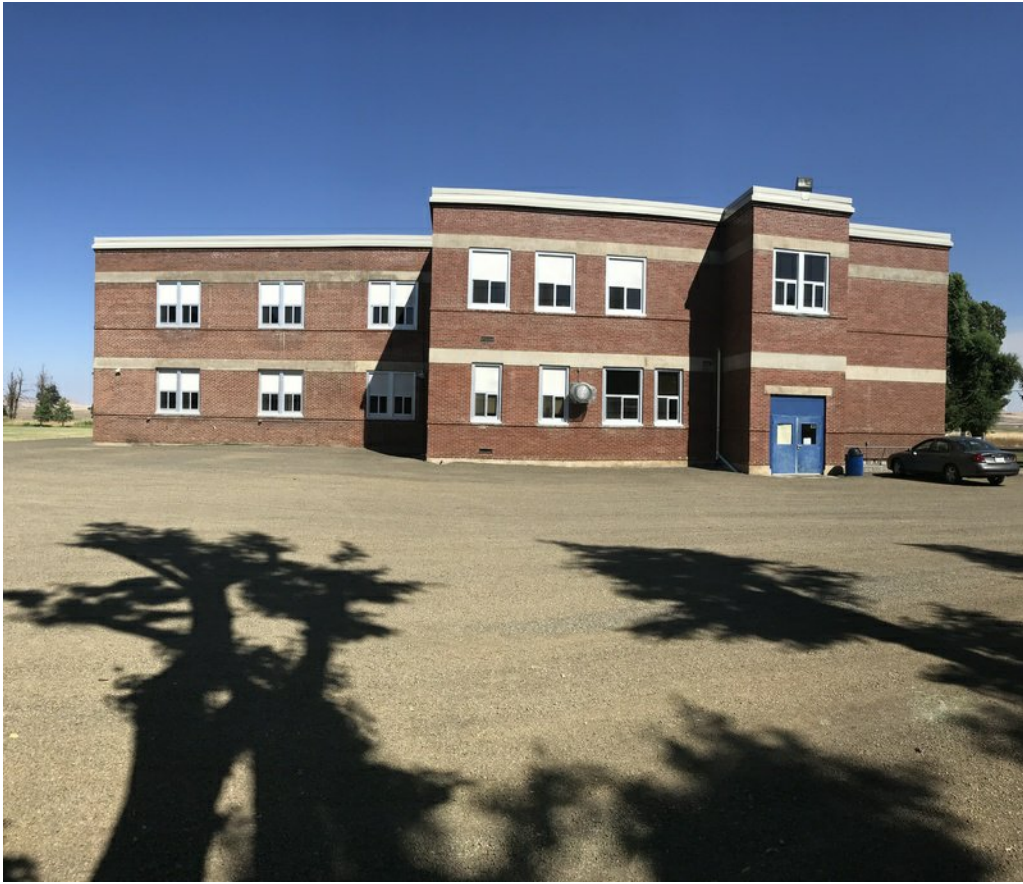
Figure 1-8. Centerville School - West Exterior

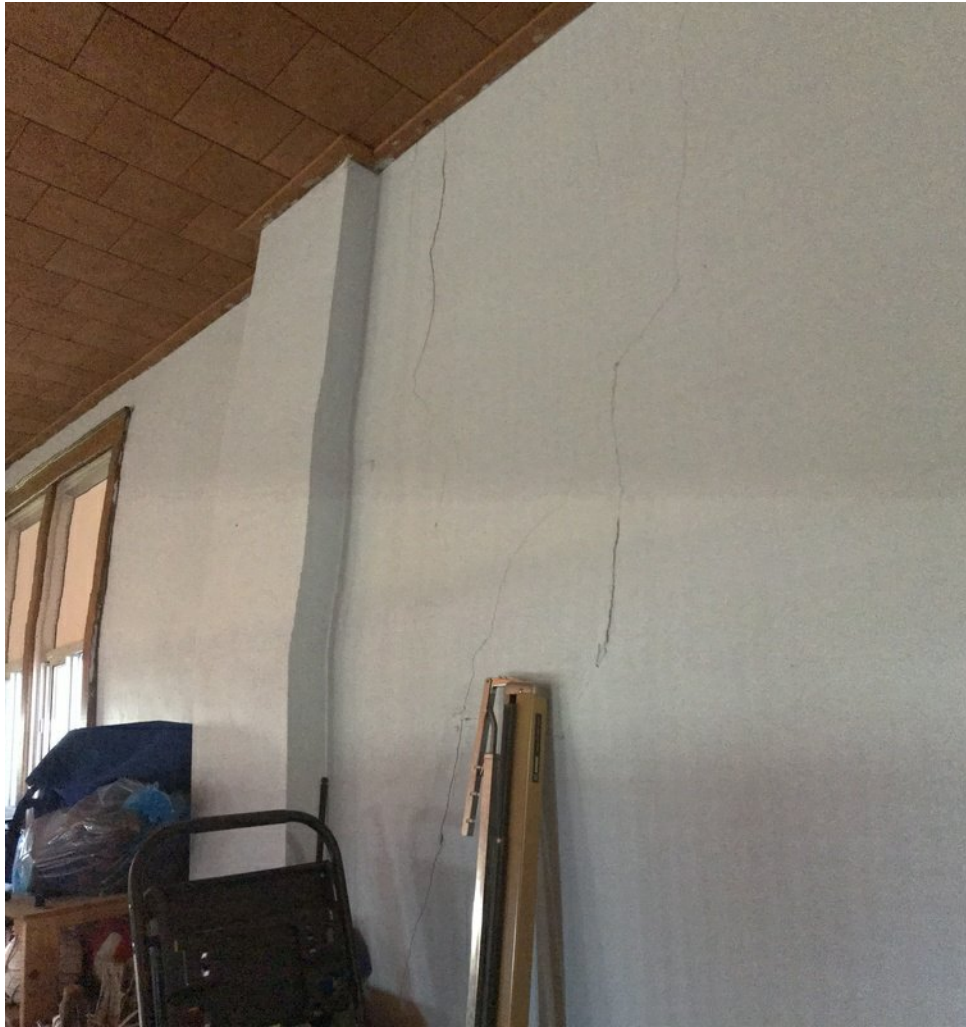
Figure 1-9. Cracking in Wall Finishes

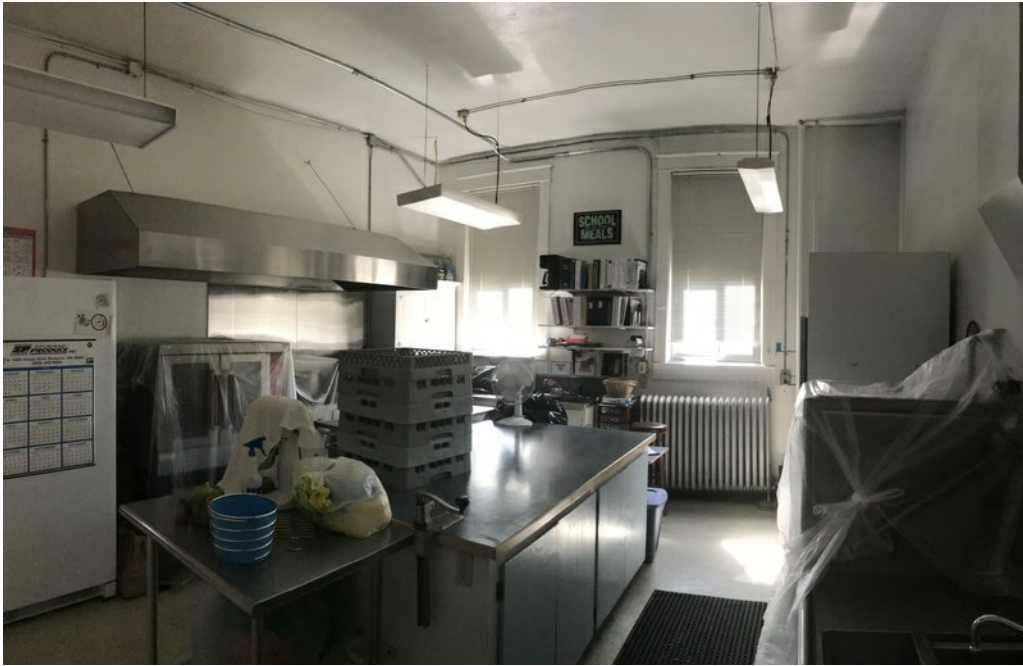
Figure 1-10. Kitchen - Unbraced Furnishing, Typical
